Results and experiences from the plastic litter monitoring in the BLASTIC pilot areas

Project	BLASTIC - Plastic waste pathways into the Baltic Sea
Work package	WP3 Results from plastic litter monitoring in the pilot areas
Preparation date	2018-12-21
Prepared by	IVL : Kalle Haikonen and Anna Fråne SEIT : Harri Moora and Evelin Piirsalu SYKE: Outi Setälä and Stjepan Budimir

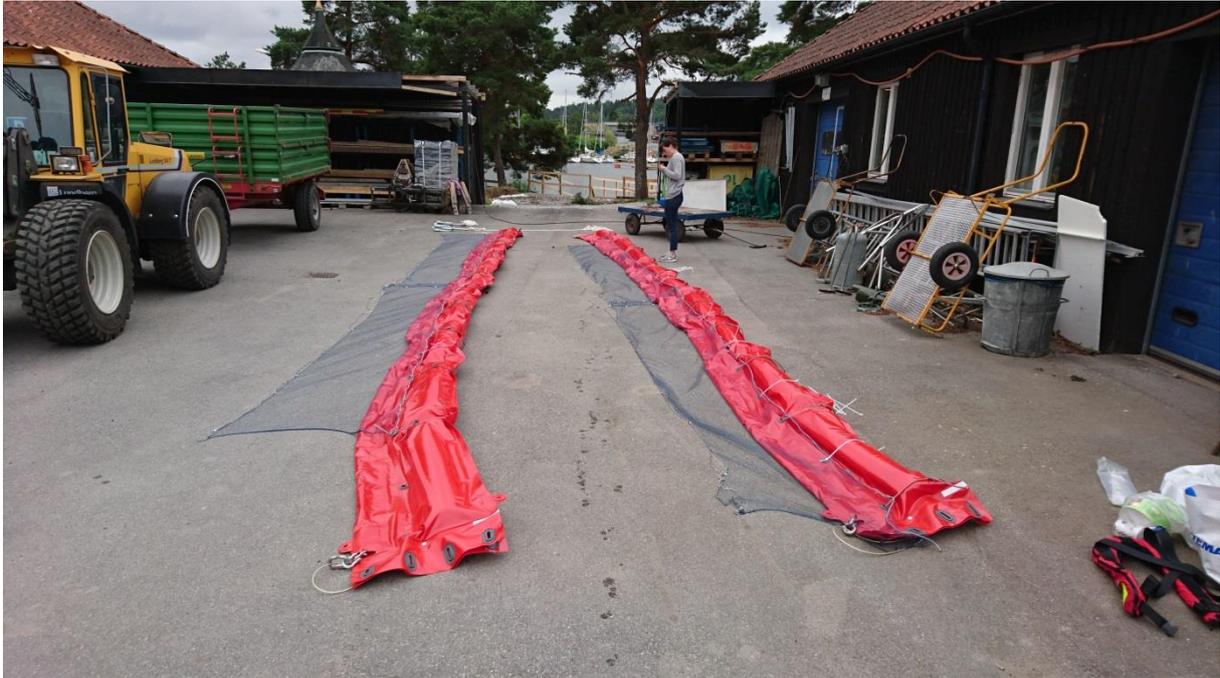
The floating litter booms used within BLASTIC were modified cylindrical containment booms (Sjuntorp C500). The general area of use for these booms is to contain oil and/or chemical spills or protect areas against floating contamination agents. As the C500 was designed for rapid and easy deployment and several booms could be connected to get a desired length they were chosen for the project. The booms were modified with additional loops so that net curtains easily can be connected to them.

Figure 1. Litter booms (C500) equipped with net curtains.

The first version with a net curtain hanging down at the bottom of the litter boom created big gaps between the net and the litter boom, as the loops where the net was attached was at the bottom of the litter boom. As plastic and other debris may "leak" through these gaps during the monitoring and retrieval of the boom another solution to attach the net curtain was considered.

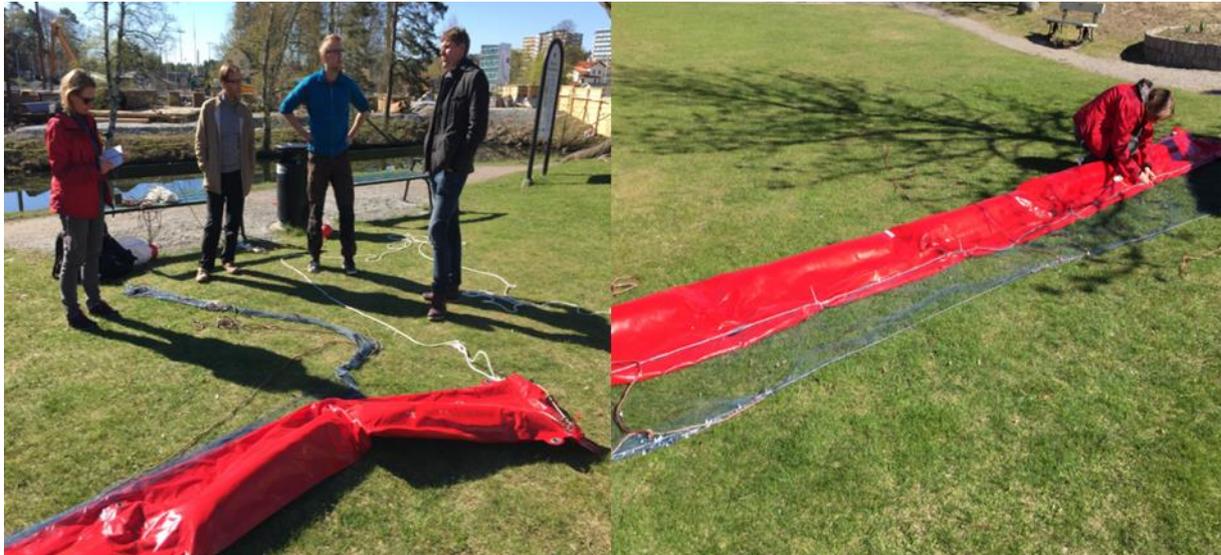
Figure 2. Test of the equipment setup in Södertälje.

A 10m C500 litter boom weighs about 35-40 kg in total and is quite bulky. The boat used was only 4.5m long and it was too small to be able to perform an effective deployment in open water. If the litter boom is to be deployed completely from a boat then a crew of three persons is recommended: one person to operate the boat and two persons who work with the litter boom. Also it's recommended to use a boat bigger than used in this initial test (4.5x1.7m) if deployed in open water. A boat that is at least 6x2m in size is recommended if one litter boom that is ten meters is being deployed. If one end of the boom is being moored to a fixed point at shore or a fixed point in the water (e.g. a concrete foundation) then a smaller boat can be used. One end of the litter boom is advantageously anchored in the fixed point first. The other end can then be towed to a desired location and moored accordingly.

The grapnels used for the mooring of the litter booms were too heavy in this pre-trial. Grapnels with the weight of 8 and 10 kg were tested. The size of the grapnels will be depending of factors that are site specific (bottom substrate and speed of the current) and the size of the litter boom. At this specific site with a soft bottom grapnels weighing 6 kg would have sufficed for the 10 meter boom. The rope length between grapnel and boom is recommended to be at least twice the depth of the water.

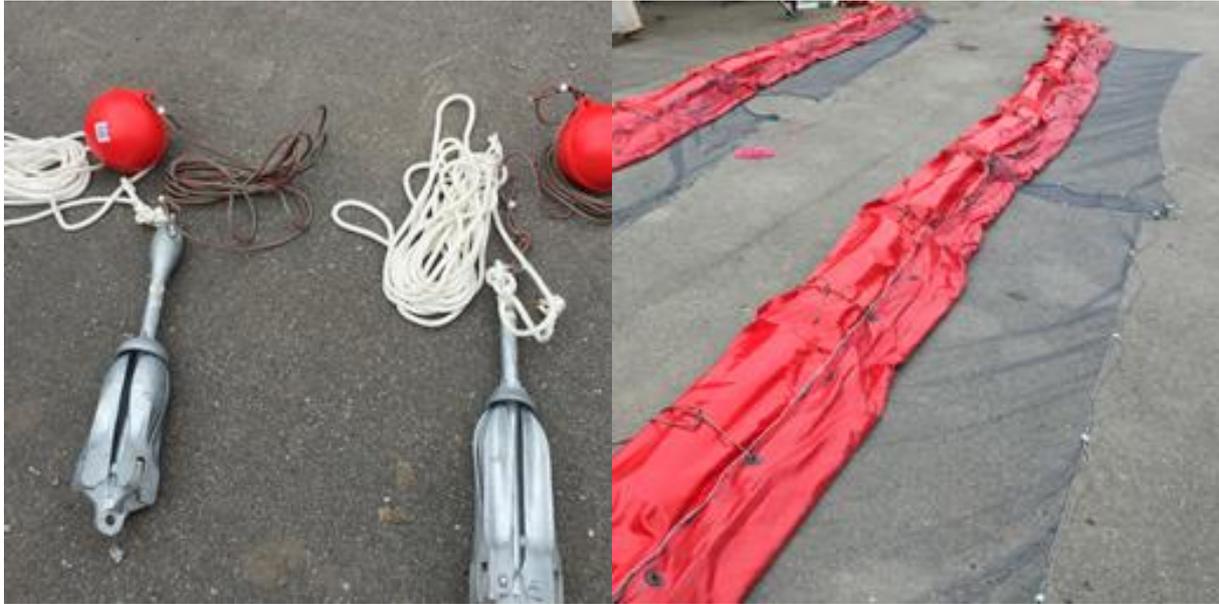
Figure 4. Grapnel anchors with marking buoys.

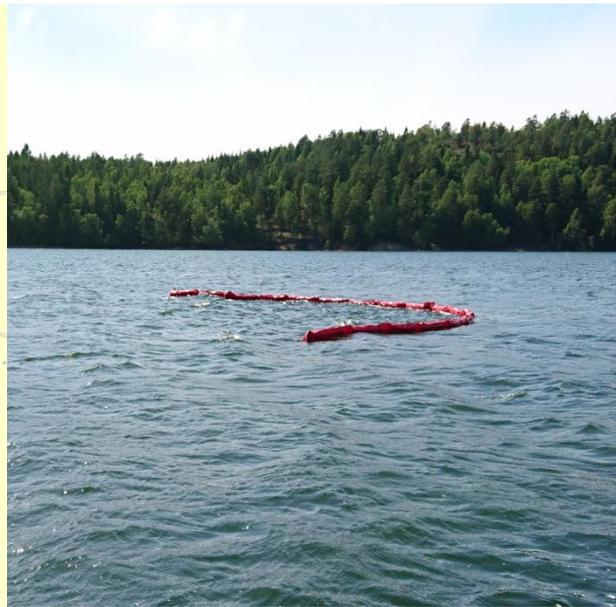
Figure 7. Boom 1 deployed in Hallsfjärden

Boom 1 was deployed on the 10th of July 2017 and was retrieved seven days later on the 17th of July 2017.

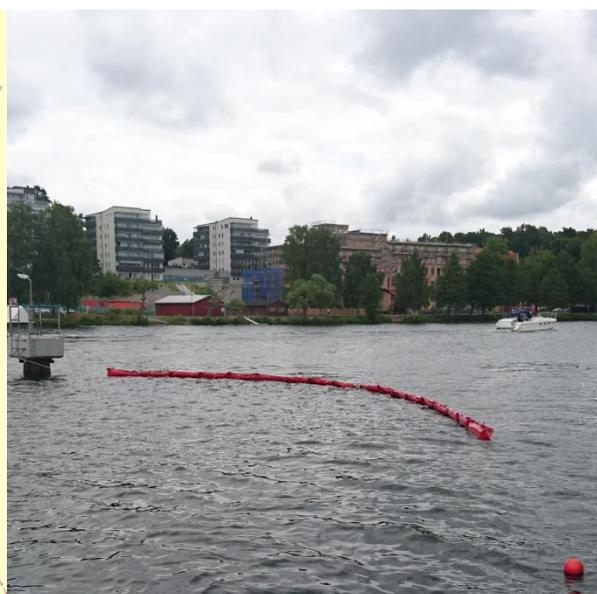
Figure 9. Boom 2 deployed at Södertälje channel inlet.

Boom 2 was deployed on the 11th of July 2017 and was retrieved seven days later on the 17th of July 2017.

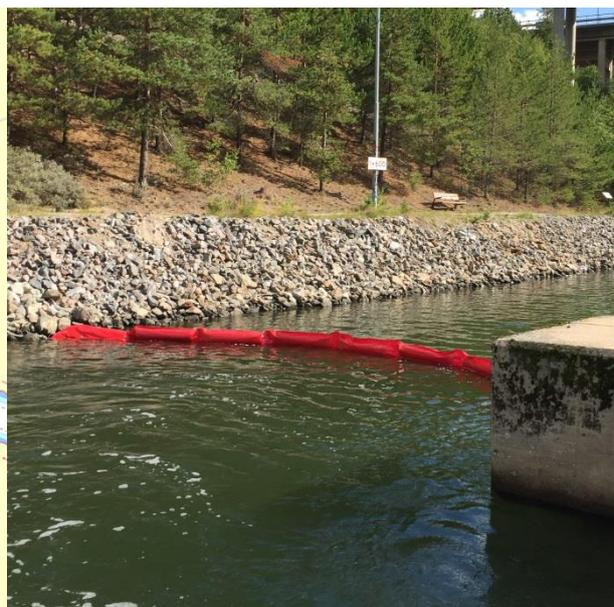
Boom 3 was placed in Södertälje channel near the channel bridge about 0.9km downstream from the floodgate (Figure 10 and 11). The water downstream from the floodgate is considered to be the Baltic Sea. The litter boom was placed between the shore and a concrete foundation in the channel. Due to heavy shipping it was not possible to place the litter boom in the middle of the channel. The depth at the site ranged between 2-3m. Boom 3 covered a total of about 15% of the width of the channel (~67m) at that location. Boom 3 was moored at a fixed point at shore in one end and the other end was moored to a concrete foundation about 10m from shore.

Figure 11. Boom 3 deployed at Södertälje channel bridge.

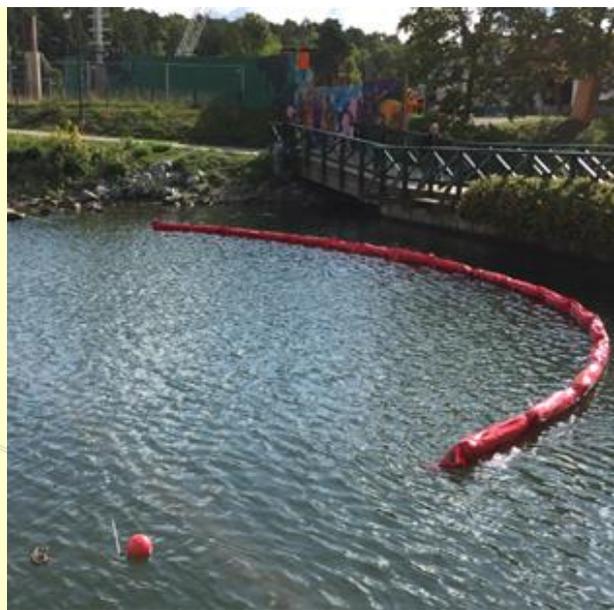
Boom 4 was placed in a small outlet in central Södertälje City called Maren (Figure 12 and 13). This outlet runs parallel to the floodgate in the city center. There is no shipping or boat traffic in Maren so the litter boom could be placed in the middle. The depth at the site ranged between 2-3m. Boom 4 covered a total of about 60% of the width of Maren (~33m) at that location. Boom 4 was moored using anchor (on soft bottom sediment) in one end and the other end was moored to a fixed concrete foundation about 3m from shore.

Figure 13. Boom 4 deployed in Maren.

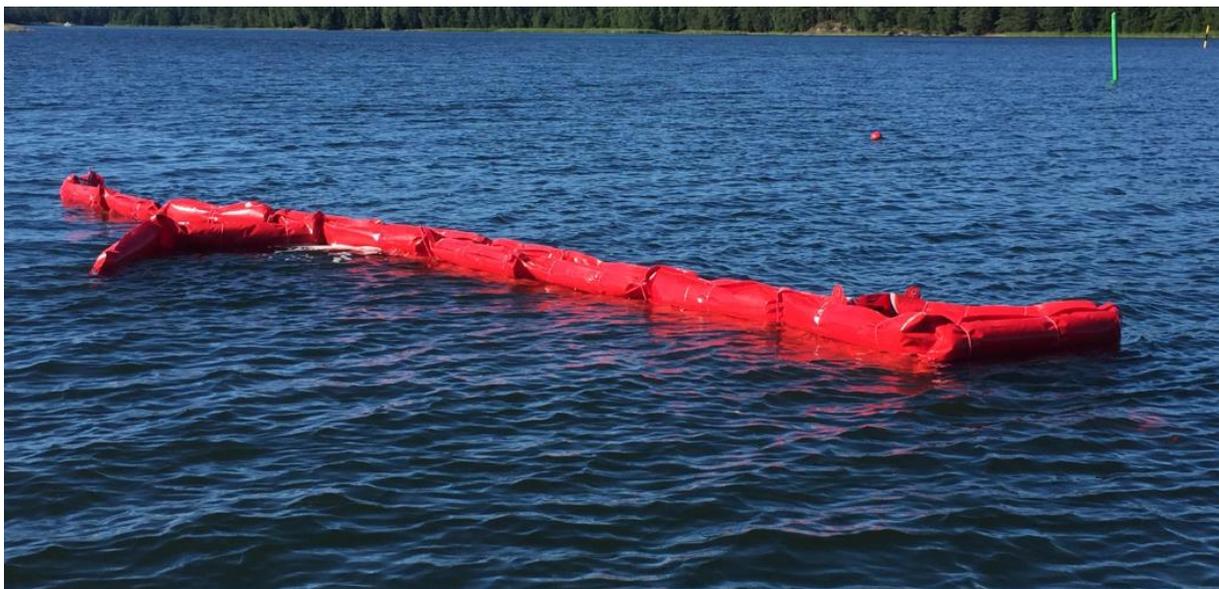
Figure 16. One mooring point of Boom 1 came out of position resulting in a deformation of the litter boom. It was not able to capture any litter.

All monitoring sessions encountered problems that affected the results in some way. The moorings of two litter booms (Boom 1 and 3) were compromised, which resulted in a drastic change in shape of the booms so that the booms could no longer capture any litter (see 3.5.1 and 3.5.3 for details). The moorings of Boom 2, 4 and 5 were not compromised. Litter was found in two booms (Boom 4 and 5). These booms were placed in Maren which lies in the city center of Södertälje. No litter was found in Boom 2, which was placed upstream of the city center. Flowmeters were used to measure the flowrate of the water at each site. However it was shown that the flowrate at all sites was too slow for the flowmeters (Oceanics 2030R) to measure. Another type of flowmeter is recommended if the flowrate is $<10\text{cm/sec}$.

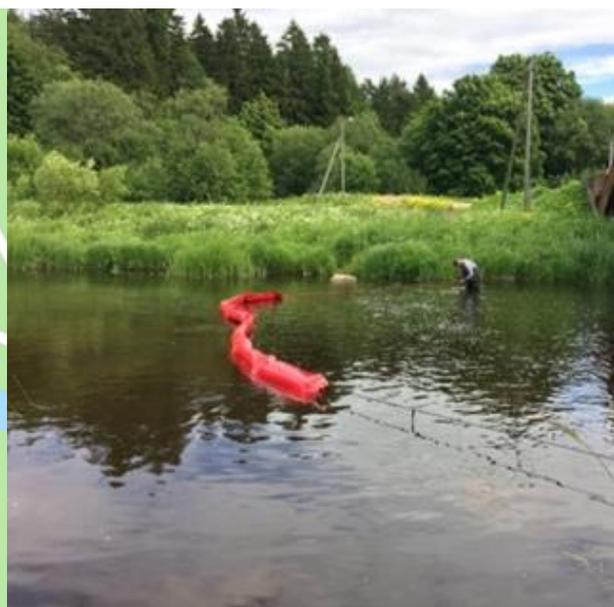
Figure 21. Installing of the boom set at Pirita Site 1.

During the first and second monitoring sessions the litter boom was used. The boom was inspected two times per day during the monitoring periods. In each monitoring period the boom covered approximately 50 percent of the river width. All floating litter items which were trapped in the boom were collected. Items larger than 2.5 cm were counted and categorized according to the BLASTIC checklist.

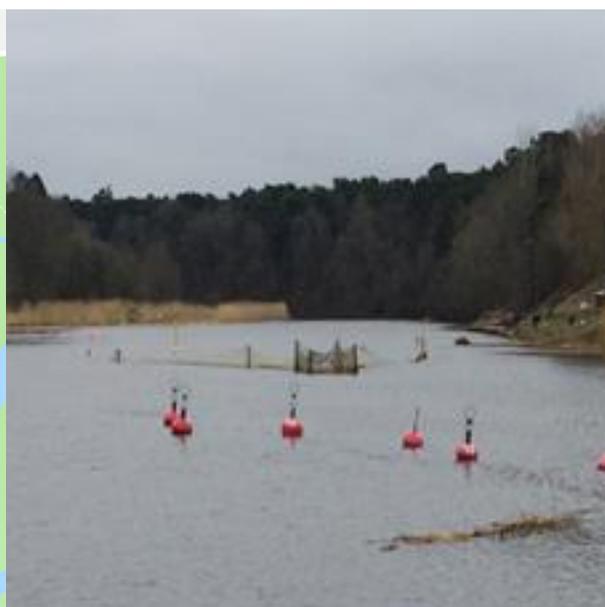
During the third monitoring session a fyke net was used instead of the litter boom. The fyke net was used by the Marine Institute (Tartu University) to monitor and assess the salmon and sea trout population in the river. The fyke net had two 10 m long wings (litter caching area length was 20 m). The net covered approximately 50 percent of the river width.

Figure 23. Set up of the fyke net at Pirita Site 2.

The fyke net was inspected once per day during the monitoring period. All floating litter items trapped in the booms or fyke net were collected and the items larger than 2.5 cm were counted and categorized according to the BLASTIC checklist (Appendix 1).

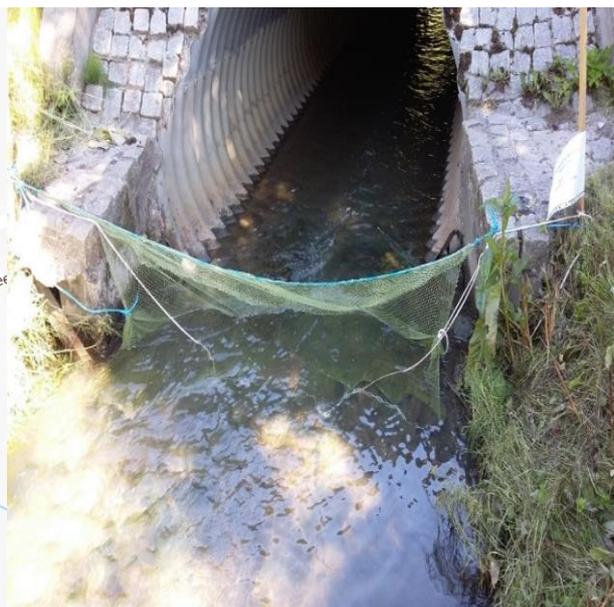
Figure 25. Set up of the net trap in the Mustjõe river.

The net trap was used during all three monitoring sessions. The net covered the whole stream (see Figure 25).

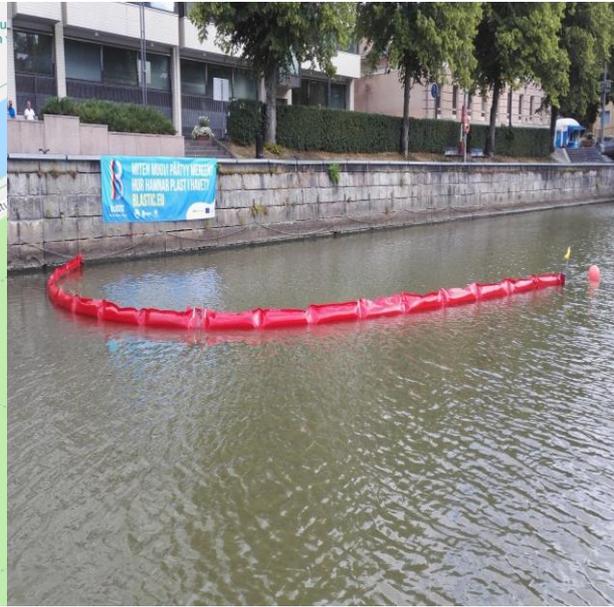
The location of the downstream booms was after bridge called Theater Bridge (Teatterisilta). The downstream booms were placed on the side of the river, anchored to the bottom from one end and attaching it to the river wall from one end (Figure 33). Because of the frequent traffic by city ferries and leisure boats it was not possible to deploy it in the middle of the river. Not only the booms, but especially anchoring ropes could have caused problems. The boom was covering about 12-15 meters of total 60 meters width of the river.

Figure 33. Downstream boom deployed in Aurajoki. Photo: Pekka Kotilainen.

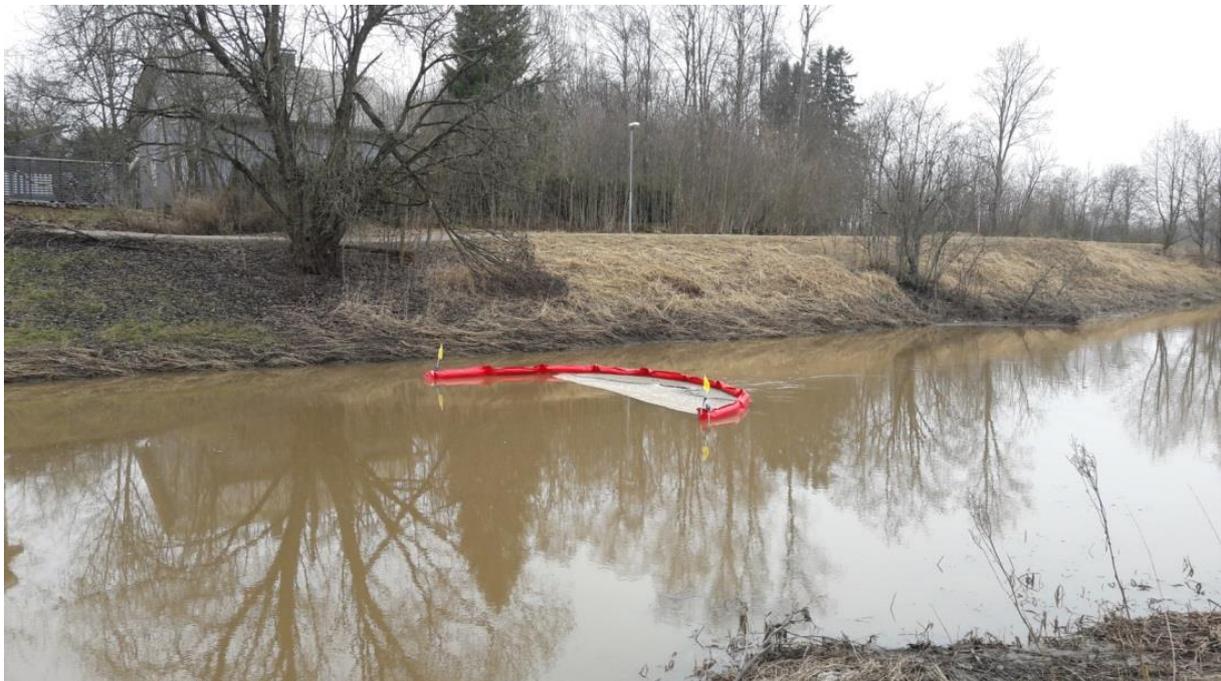
For the monitoring of floating litter, one 10m long boom per study site was deployed (Figure 38). The booms were inspected daily between the 24th and 26th of April). Litter from the booms was collected, counted and categorized by material and item. The water current profile at each location was measured each morning on the days of litter collection with an Acoustic Doppler Current Profiler (ADCP –device). ADCP measures water currents with sound by using a principle of the Doppler effect.

Figure 38. The upstream boom at the Kerava branch. Photo: Outi Setälä.

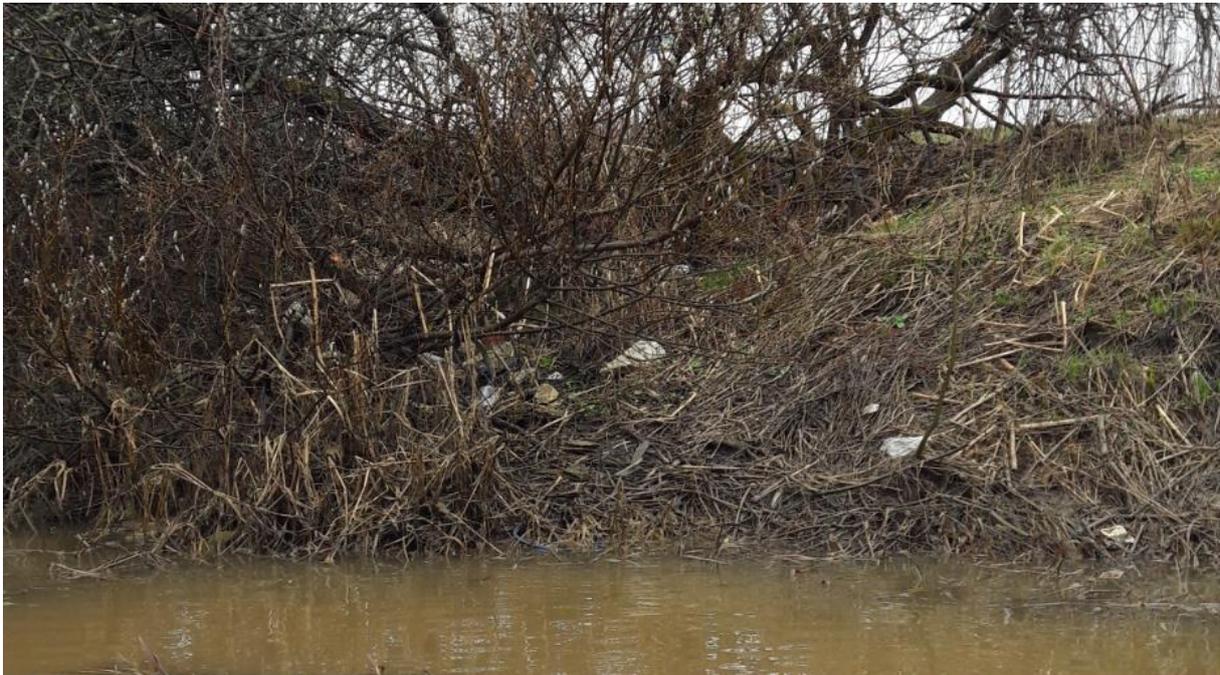
**Figure 41. Litter items on the riverbank at the junction of the two rivers.
Photo: Outi Setälä.**

In the year 2018 air temperatures below 0°C prevailed longer than in average years. After this period the temperatures rapidly increased and the thermal spring in the southern parts of Finland started. This resulted in fast melting of snow and elevated riverine water levels. This dynamics was also observed close to the discharge site of the river to the sea, where the water level fluctuated greatly within three weeks: 6.29 m (3rd of April), 7.11m (10th of April) and 6.49m (26th of April). Thus the high water level maximum took place two weeks before the deployment of the booms and had by then already lowered by 62 cm. During the high water period (7th to 22nd of April) the water discharge was between 45-70m³/s at a regular monitoring site in Oulunkylä (500m upstream from the lower boom). Already by observing the amount of litter on the riverbanks it became obvious that the high water period was efficiently transporting various litter items, which were trapped on the river banks when the water level decreased (Figure 41).

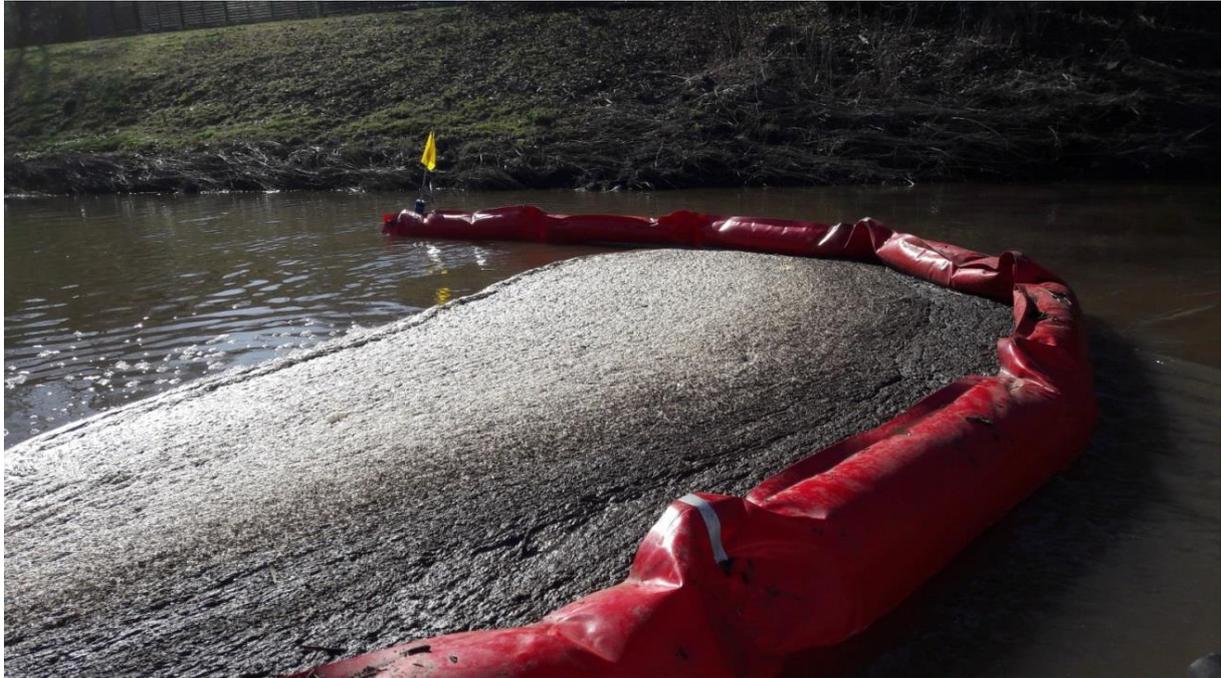
Most of the material which the booms had captured consisted of parts of various plants which were growing on the riverbanks. The suspended material of the river water formed large patches of foam to the boom (Figure 42).

Figure 42. Foam formed inside the boom during a 24h period (between two samplings). Photo: Outi Setälä.

This probably did not have any effect on the capturing efficiency of the booms. In overall the number of litter in the booms was minor: altogether only 119 items were obtained during the monitoring period (Table 13). From this amount 82% was collected from the upstream boom at the Kerava branch, flowing through the urban Tikkurila area. The share of foamed plastics (EPS) was high at the upstream sites. The prevalence of EPS was evident also on the riverbanks, where a high number of EPS which was identified as insulation material was found. At the downstream boom the overall number of captured litter remained small. It is likely that the litter items from the spring period had already accumulated on the riverbanks between the upstream and downstream sites, as probably also litter from previous years had accumulated. The amount of litter at certain sites at the riverbanks was too high and also seemingly aged to have derived there only during the last spring. This was also confirmed by the regular users of the river, such as kayakers who claimed that only a few weeks earlier the river was transporting not only floating ice and branches of trees and plants, but also lots of litter, especially plastics.
