# INSURE

Innovative Sustainable Remediation

## REPORT ABOUT PILOT TESTS

5/2019 UHEL

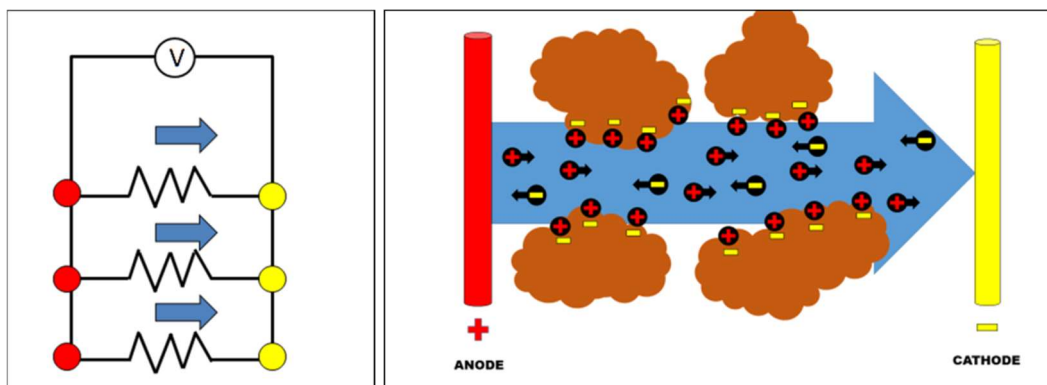
**Figure 2.1 a-b.** a) The parallel circuit from above, with the movement of the aqueous phase shown in blue arrows. b) cut-view of the mechanism in soil. Soil particles bind ions from the aqueous solution due to their surface charge. The opposite ions remain free in the aqueous media and travel in the electric field according to their charge. Due to its viscosity, water is being dragged along in a horizontal movement and the radius of influence is hence increased.

In biological remediation of sites contaminated with organic compounds, the naturally occurring biological degradation is accelerated by removing the possible bottlenecks of biological activity. The ones most often targeted are lack of oxygen or another electron acceptor, lack of nutrients, of which nitrogen is the most important in terrestrial systems, and lack of moisture when working in the non-water saturated zone. In these cases nutrient amended water is injected into the contaminated zone via ground water tubes. With horizontal tubes the problem may be that the radius of influence is rather limited, and the nutrients end up in ground or surface water instead of the contaminated zone itself. Electro-osmosis can then be introduced to increase the horizontal vector of the injected water. The principle is explained in Figure 2.1.

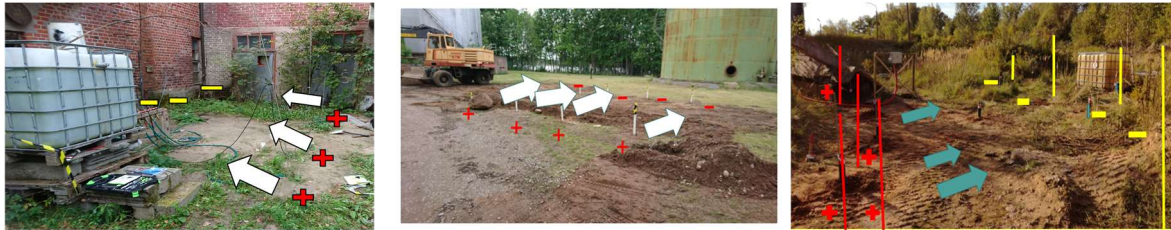
**Figure 2.2 a-c.** a) Site Villähde, non-saturated zone application b) Site Motala, below ground water level application c) Site Valmiera, non-saturated zone application reaching the ground water level

The method was tested at three sites, Villähde, Motala and Valmiera, all of them distinct in regards to the groundwater level conditions (Figure 2.2). Aim of the research was to develop applications for both non-saturated zone and below groundwater level contamination.

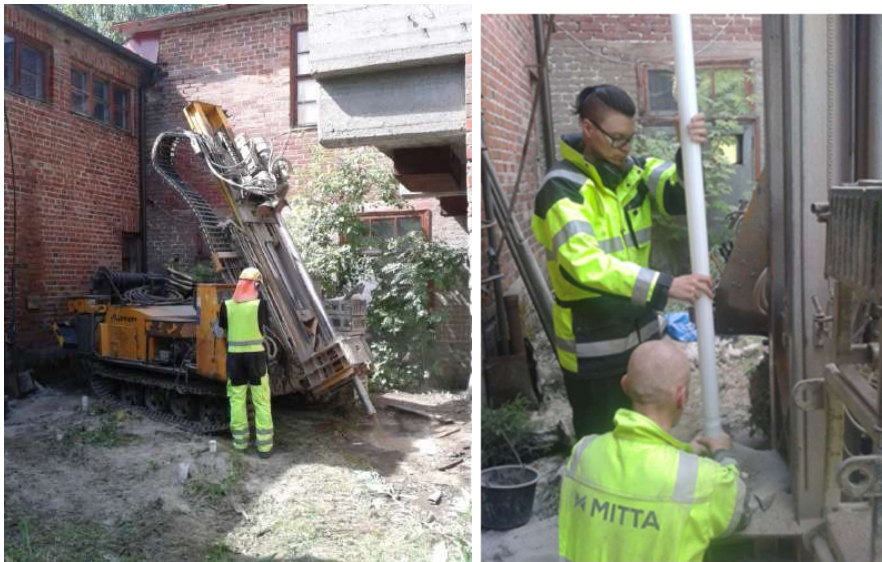
**Figure 2.3 a-b.** Drilling (a) and installation of perforated tubes (b) at site Nastola in June 2016.

In June 2016, the site was prepared for the *in situ* treatment. In total six drillings were performed to depth 12 m, to enable the installation of two rows of electrodes in perforated plastic tubes (Figure 2.3). The cathode side was thoroughly sampled: samples from depths at which 2/3 of the samples had a strong diesel odor were analyzed for oil hydrocarbon content, resulting in samples from depths 7 to 11 m being analyzed. The treated zone was 10 m x 3 m x 3.5 m and approximately 100 m<sup>3</sup> in volume and 130 t in mass.

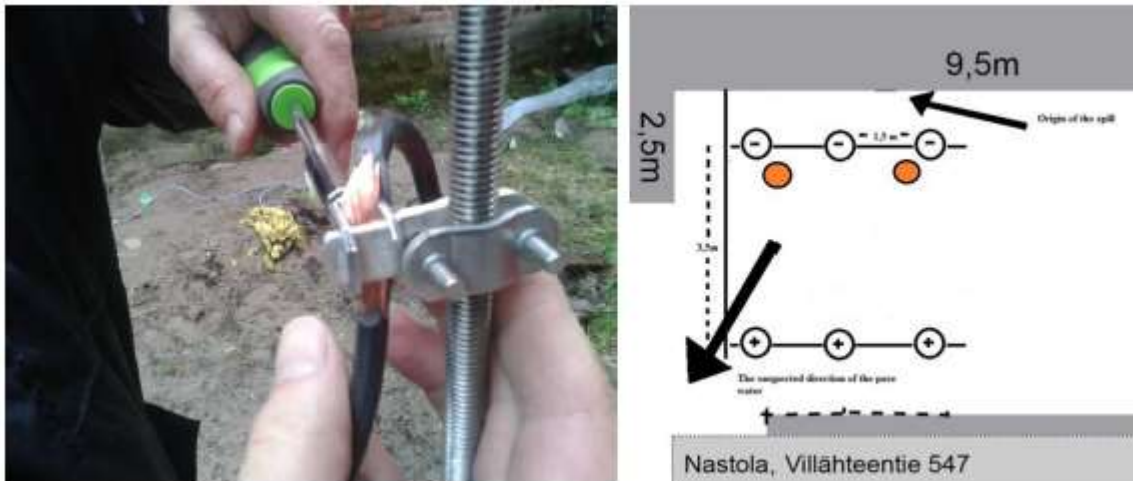
**Figure 2.4 a-b.** Installation of the electrodes (a). Technical drawing of the area from above (b) Original sampling performed from cathode wells (-), control sampling locations marked by orange spots. The black arrows indicate the origin of the spill (above the cathode row) and the suspected direction of the ground water (to bottom-left)

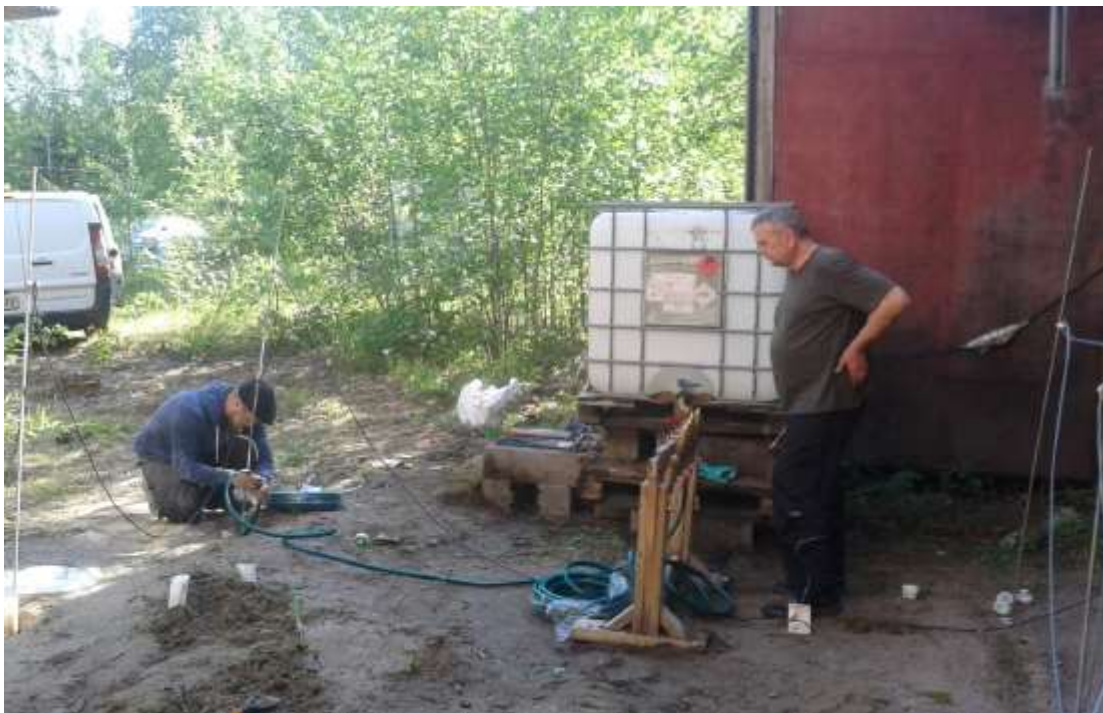
**Figure 2.5.** Installation of the water injection system.

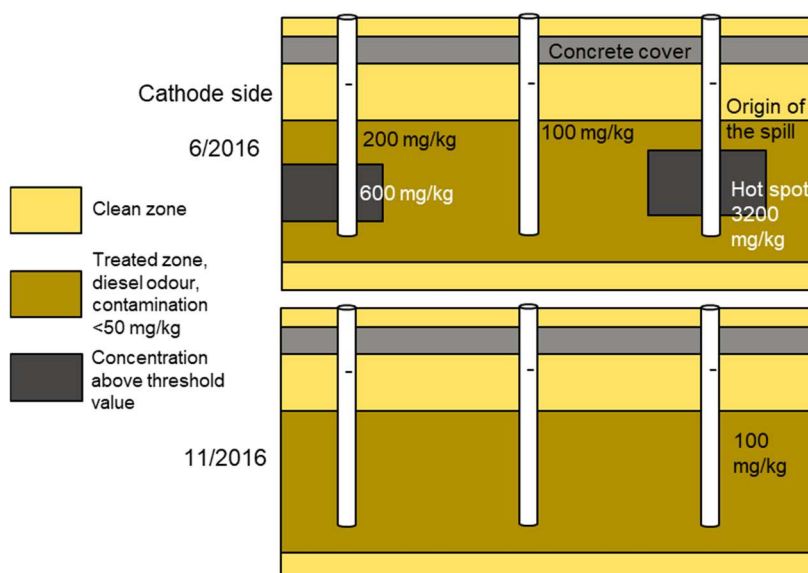
**Figure 2.6.** A cross-section portrait of the cathode (-) side before and after treatment.

The concentrations in the soil prior to the treatment were mostly under the detection limit even when a strong odor was observed. Two of the 15 samples had concentrations exceeding the threshold value for C10-C40 oil hydrocarbons (300 mg/kg) and the lower guideline value for C10-C21 distillates (300 mg/kg) with an obvious hotspot of 3200 mg/kg dw in 7-8 m depth, near the origin of the spill. After the treatment, three samples with concentrations over the quantification level (LOQ) had average concentration of 100 mg/kg dw and no hot spots with higher overall concentrations were located. The situations before and after 4.5 months of active treatment are shown in Figure 2.6.

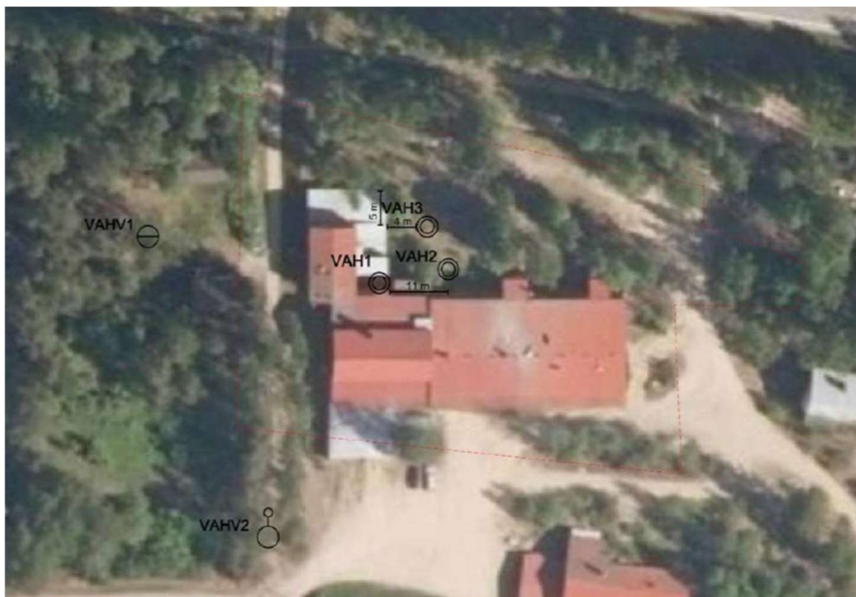
**Figure 2.7.** The site investigations done by consultant Vahanen Oy with the sampling spots marked.

An independent party, consultant Vahanen Oy, performed the final investigations of the area in April 2017. The soil was sampled in three drillings VAH1-VAH3, with VAL 1 within, and the other two southeast from the treatment zone (Figure 2.7). An organoleptic survey of approximately 1 m length soil columns from depths 8-14 m was performed prior to the standard analysis. Groundwater was investigated from two groundwater wells: VAH 1 to the west from the premises and VAH 2 south from the treated zone. No traces of oil hydrocarbons were found on the site at concentrations above or near the threshold value, and it was concluded that no further actions would be required, neither on the study site nor on the larger area suspected to have been impacted by the spill.

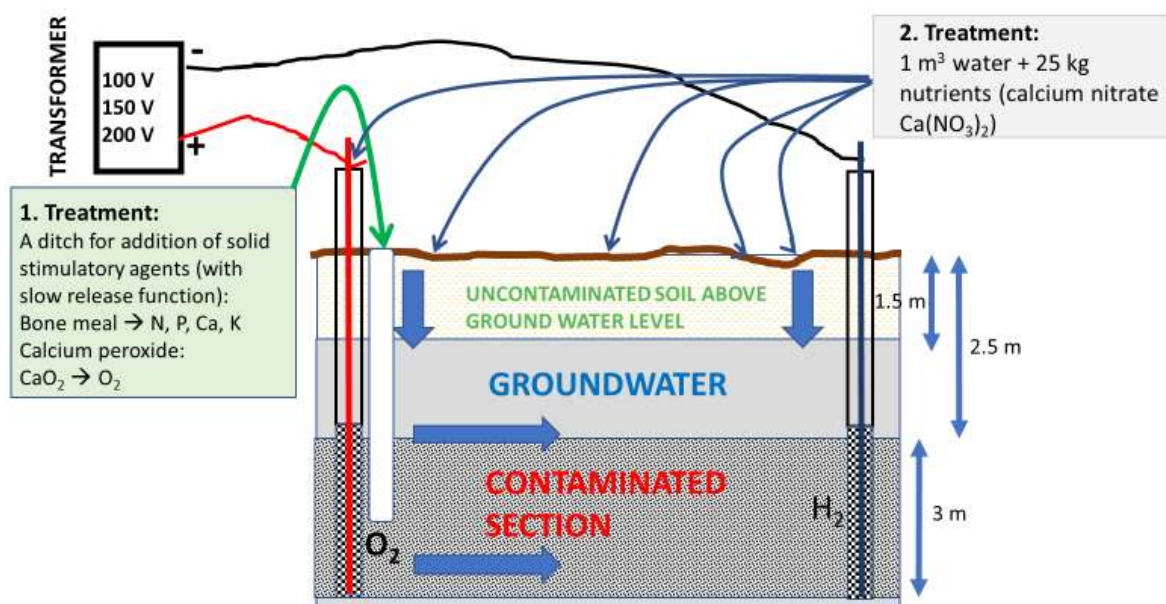
**Figure 2.9.** A schematic representation of the situation and treatments at Stenavadet. Later obtained data indicated that the water level was fluctuating during the treatment period.

The anode (+) electric cord was attached to the row of electrodes further from the lakeshore, and the cathode (-) cord to the row closer to the lakeshore (Figure 2.9). This arrangement was based on the assumption that the main direction of groundwater flow would be towards the lake. The voltage was turned to the smallest 100V position. The current was measured separately for each of the electrodes.

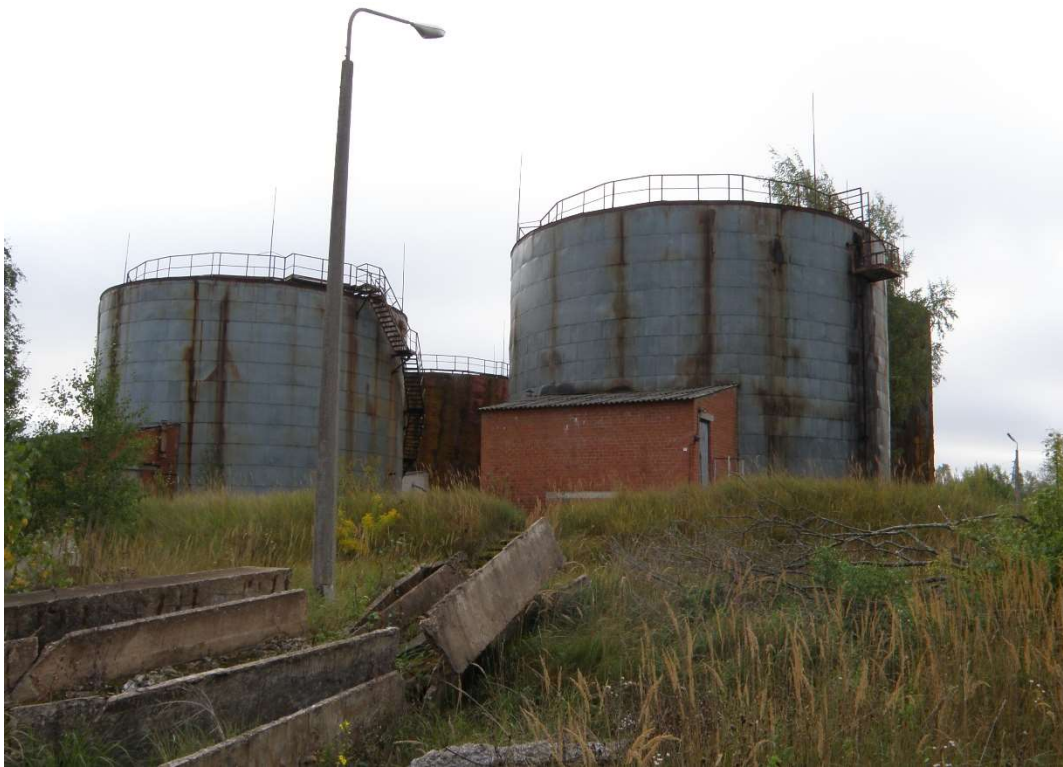
**Figure 2.12.** The old oil cisterns at the pilot site.

Site Dzelzcela iela 9 is a former fuel facility of the heat producer Valmieras siltums Ltd, located to the south of the city of Valmiera, in the industrial area. The area of approx. 1.2–1.5 ha has been formerly used for the storage and transshipment of oil products. Nowadays the area is abandoned with partially demolished buildings, fuel tanks and reservoirs (Figure 2.12).

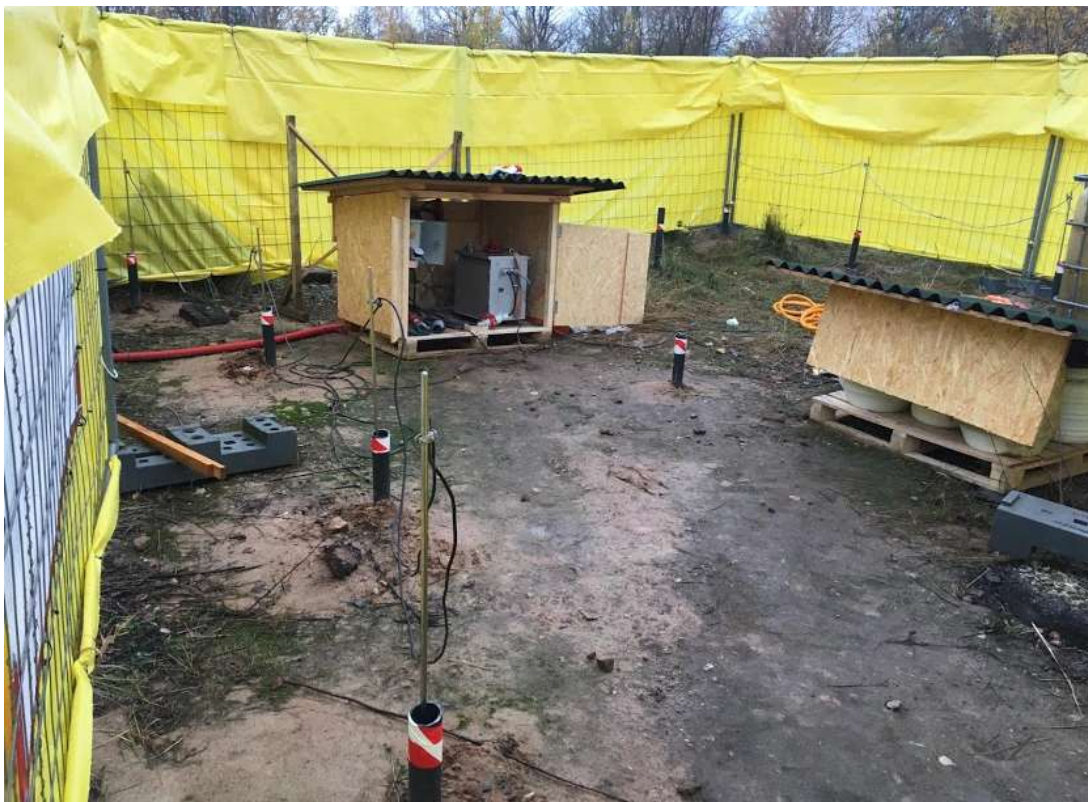
**Figure 2.14.** Finished site installations. The anode side on the left, the cathode side on the upper right near the fence. Tubes in between mark monitoring sampling spots.

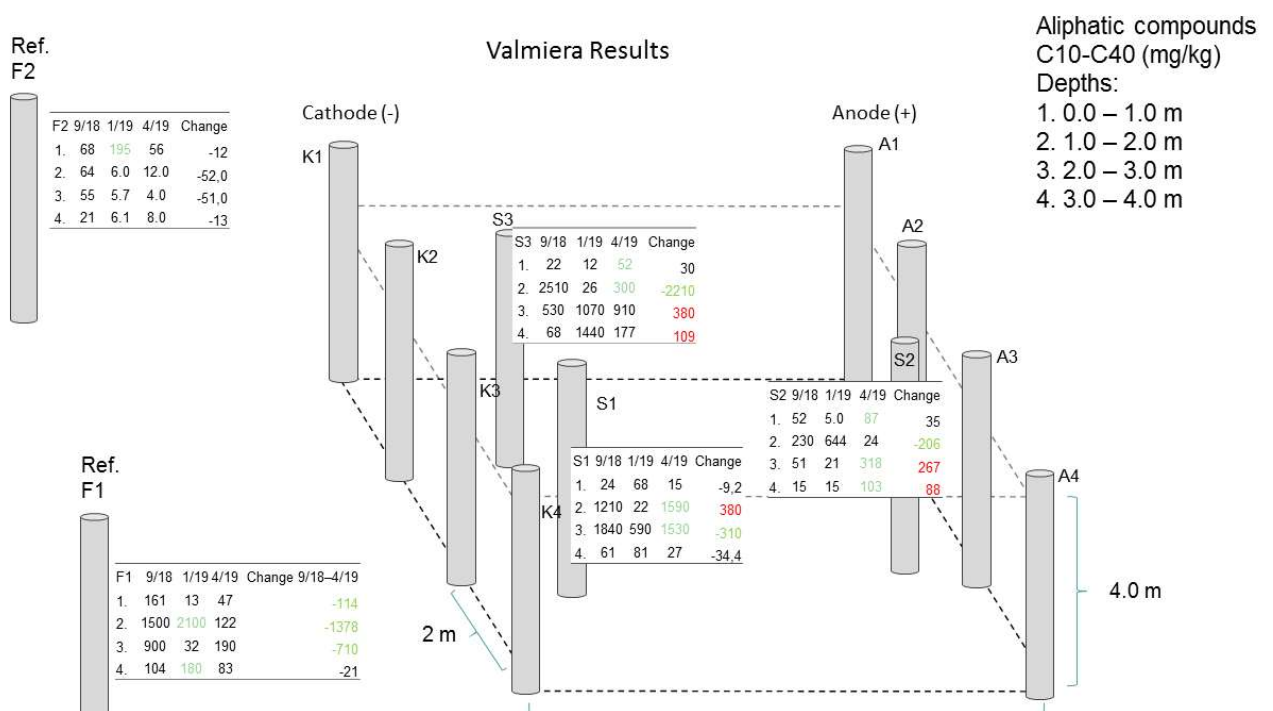
**Figure 2.15.** Oil hydrocarbon results from soil, from investigations in 9/18, 1/19 and 4/19.

All samples taken before the treatment had a distinct odor, with the samples from, or near, the cathode row and the control sample some meters behind the treatment area appearing to have the highest concentrations. In the area between the electrode rows concentration of C10-C40 fractions were not found to have decreased in a considerable fashion (Figure 2.15.). An approximately 10% decrease in average concentrations was documented, whereas with both positive and negative changes recorded, reductions in this scale could not be considered significant or strictly associated with the treatment, but also resulting from heterogeneous distribution of the contaminant in soil. Largest average reduction was observed in reference spot 1, which was however located into the direction towards which the injected water was flowing, separated from the treatment area with a zone containing underground structures, and therefore likely of decreased local permeability.

It can be concluded that with a site of such a low permeability, the treatment time of six months was not long enough for visible trends to overcome the differences in contamination level caused by soil heterogeneity alone. What could be verified was that the electro-osmotic application of the particular biostimulation protocol was not a financially sound way to treat the site in question as excessive amount of energy was spent with little remediation effect. One probable cause for this was the fact, that the electrodes were reaching the ground water level and large portion of the electricity would be spent in generating heat in the groundwater without significant horizontal movement of pore water achieved in the non-saturated zone.

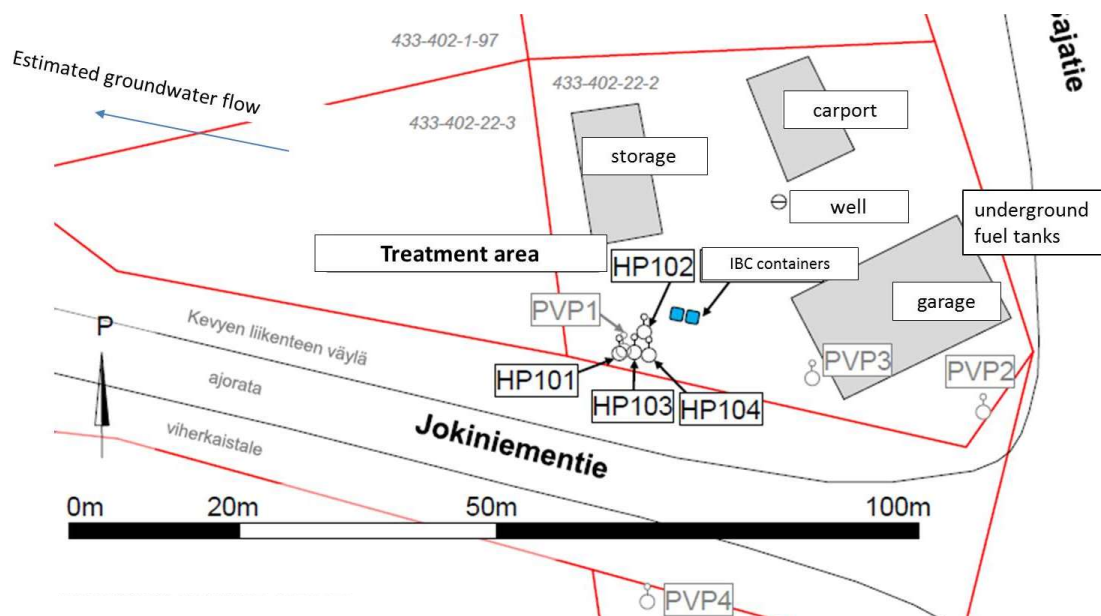
**Figure 3.1.** A technical drawing of the site Loppi (Jokiniementie 240) with groundwater tubes PVP1-4 and installed monitoring tubes HP101-HP104 marked.

Most of the yard is under an asphalt cover. First meter under the cover is gravel, under which there are up to five meters of silty clay with narrow sand stratum. The site belongs to a classified groundwater area with groundwater level starting at the depth of 3-4 m. The well situated on the site is not in use, and other wells near the immediate area of impact have not been located. The suspected direction of the groundwater is towards North-West or West, that is, towards River Isojoki (Figure 3.1.).

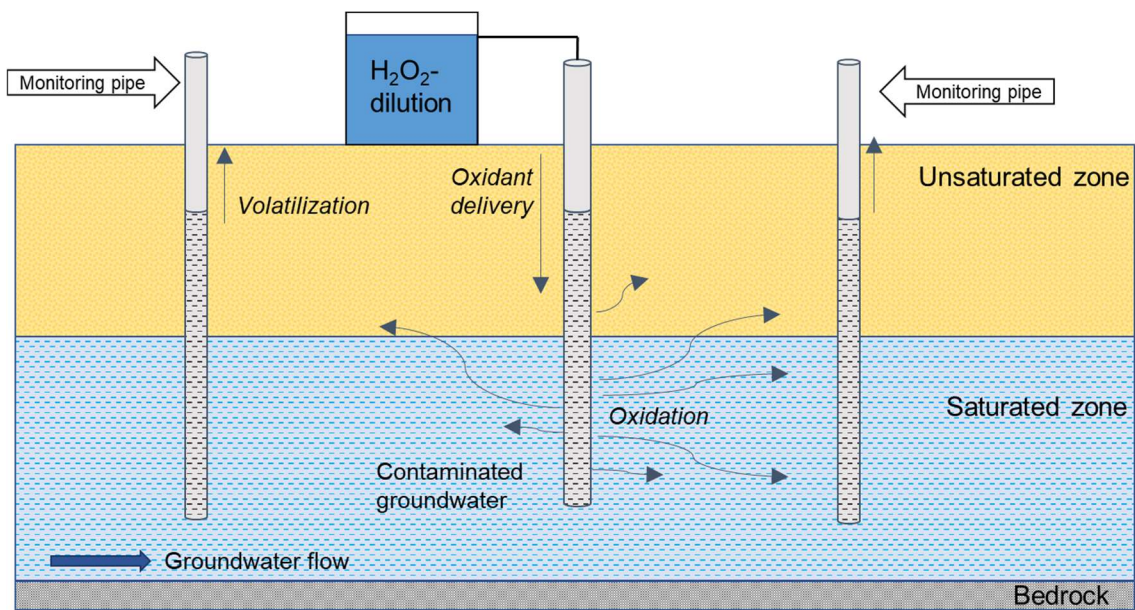
**Figure 3.2.** Principle of peroxide sparging in the saturated zone

For the experimental set up, four vertical groundwater pipes were installed to a depth of 5.5 m, with perforation starting at a depth of 0.5 m and hence set to cover only the saturated zone. Protective covers were installed to cover the first meter of the pipes from the top down (Figures 3.2 and 3.3). H<sub>2</sub>O<sub>2</sub> injections were started two weeks after the installation. Groundwater was sampled prior to this and air-VOC measurements (using a photoionization detector, PID) were recorded from all groundwater wells in the area.

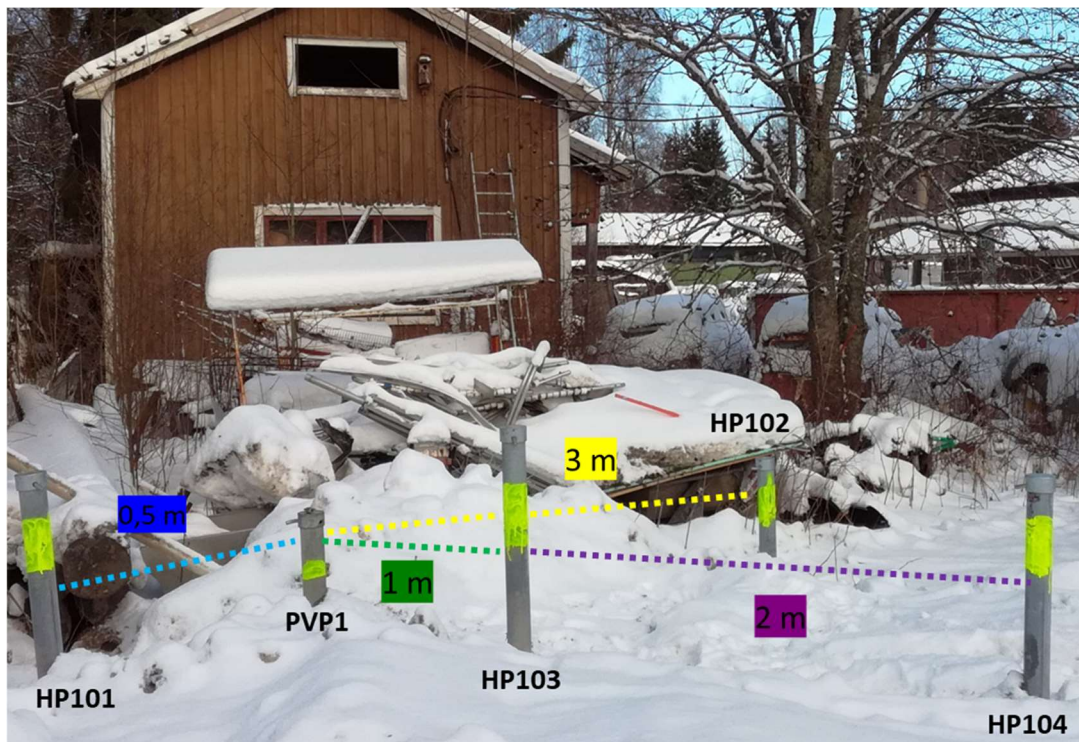
**Figure 3.3.** The original treatment area showing the distances between each groundwater pipes.

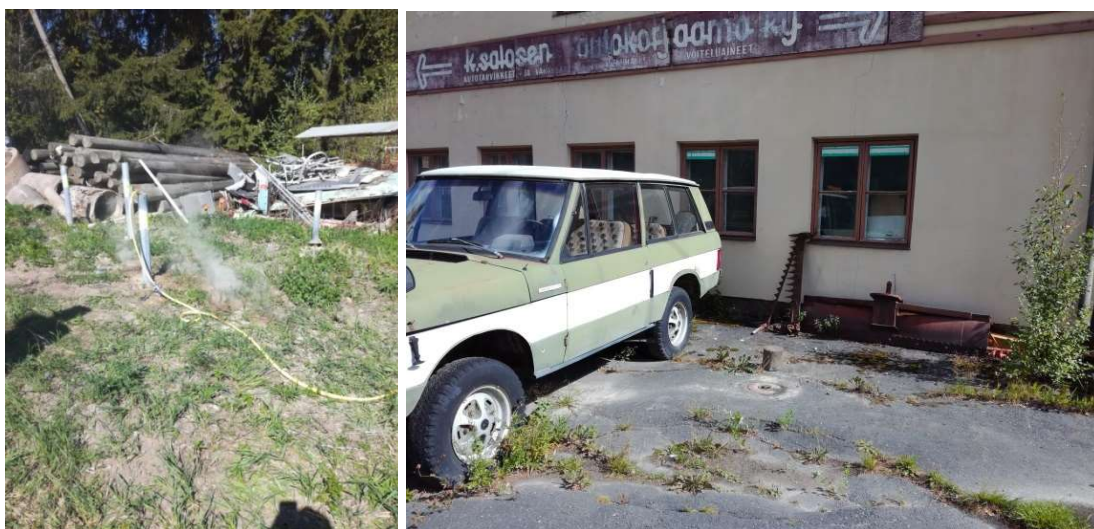
**Figure 3.4 a-b.** PVP1 area (a) and PVP3 area (b) during the second period of the experiment.

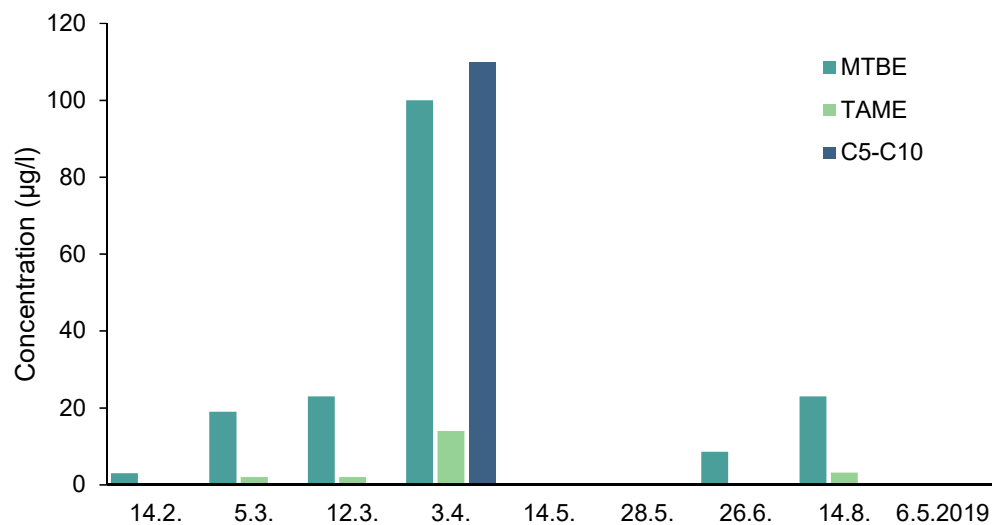
**Figure 3.5.** The concentrations of MTBE, TAME and C5-C10 ( $\mu\text{g/l}$ ) in monitoring pipe HP104.

One month after the second stage of remediation, it was found that the concentrations of MTBE in these tubes had increased compared to the initial concentrations. In addition, TAME was detected in small concentrations in both tubes. The concentrations of VOCs analyzed from tube HP102 were still below the LOQ. The remaining two tubes were not sampled due to the previously clean samples. The site was revisited in May 2019 to see whether the concentrations had rebounded. None of the targeted VOCs were detected from samples taken from the pipes HP104 and PVP1, indicating that the original treatment area was still clean.

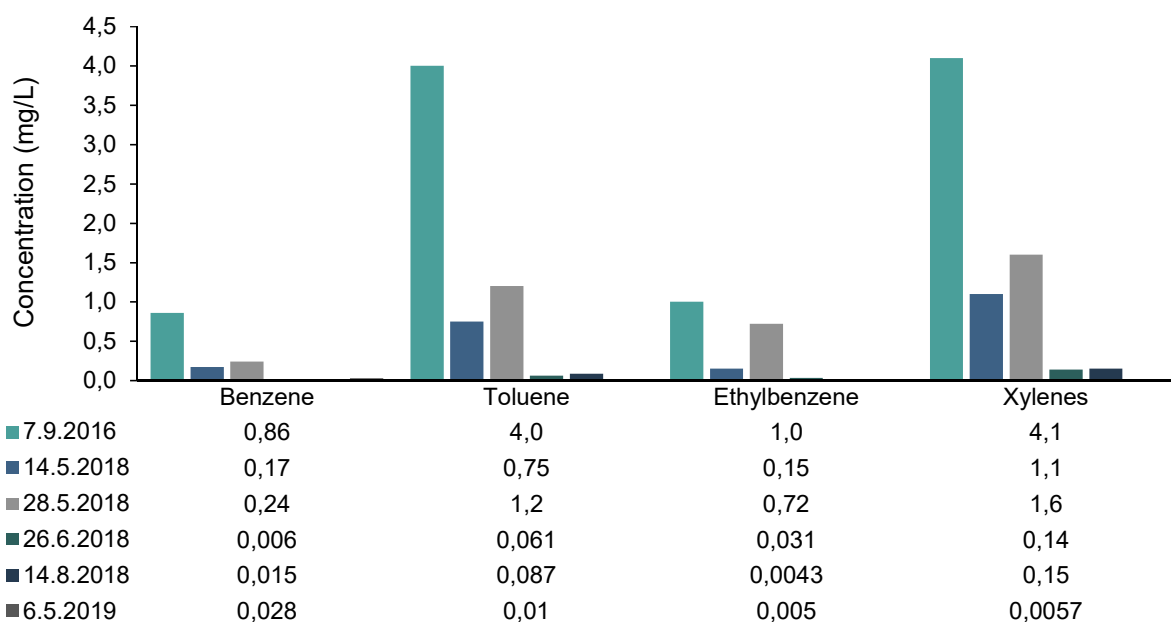
**Figure 3.6.** BTEX concentrations in groundwater before (2016) and after H<sub>2</sub>O<sub>2</sub> injections.

As the concentration of VOCs in the original treatment area had already decreased below LOQ, the treatment was continued in the groundwater pipe PVP3. In 2016, BTEX compounds and gasoline fractions were found in this pipe at levels exceeding water quality standards or the maximum irrigation water concentrations. In a couple of years, concentrations have naturally declined; the decrease has been 73-85%, depending on the compound (Figures 3.6 and 3.7). At the beginning of the treatment, BTEX and gasoline concentrations increased slightly, but in less than a month a decrease was documented. One month after the end of the experiment, slight rebound in concentrations was observed. However, the end concentrations were 88-97% lower than at the beginning of the second stage.

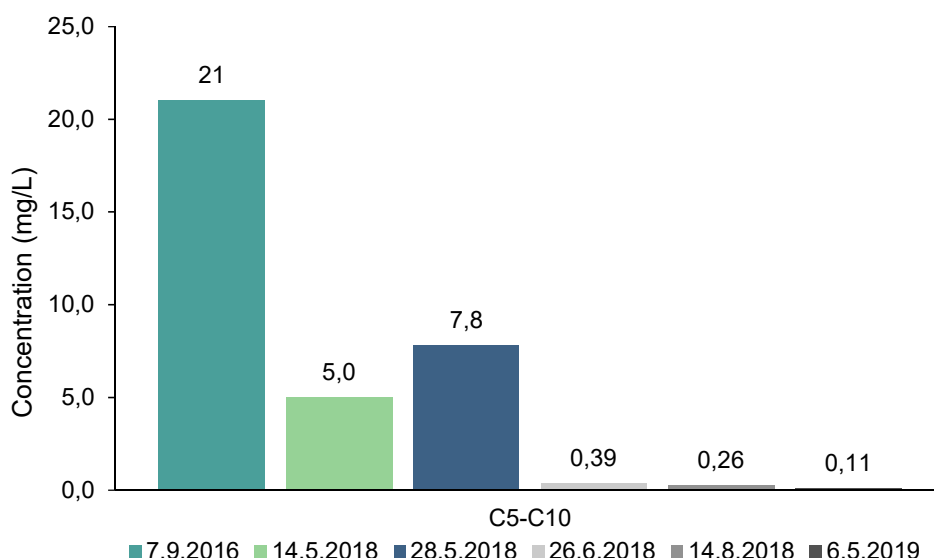
**Figure 3.7.** Gasoline concentrations in groundwater before (2016) and after H<sub>2</sub>O<sub>2</sub> injections.

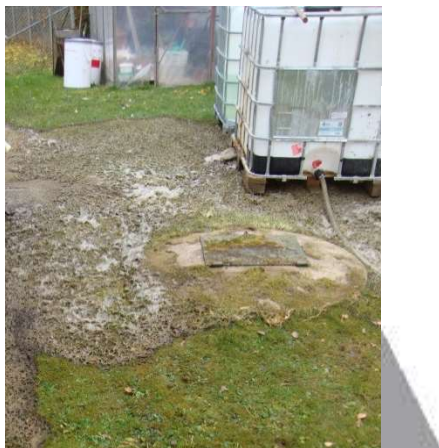
**Figure 3.8 a-b.** The site after the chemical oxidation treatment (a) and a drawing of the tank with the sampling spots in red (b). Only the results from the three spots on the bottom axis have been used for the surveys, because the other two are higher up the ceiling from where samples could not be withdrawn during all stages of the treatment and also since these concentrations were found to be negligible by comparison.

Since it was suspected that the soil under the tank was coarser and had higher oil concentrations, the sampling and water injections were to be performed through small holes in the tank itself. For this, five holes (4 cm ø) were drilled (Figure 3.8.). All samples were sent to Synnlab Oy for oil hydrocarbon analysis. Most remediation activities in project INSURE were found to cause soil mobilization, which resulted in large amounts of soil being pushed into the tank via the injection holes. This soil was found to be relocated from the sides of tank leaving a gap between the tank jacket and the soil, making two of the sampling spots unfit for sampling at certain points of the experiment. Because of this, even when these samples could be withdrawn, average values were calculated from the three spots at the bottom for the treatment follow up. Oil concentrations at the bottom were approximately hundred times higher than in the soil higher up the tank ceilings. Light fuel oil concentrations of 25 000 mg/kg in average were measured from the samples withdrawn from the first 30 cm under the tank prior to the treatment.

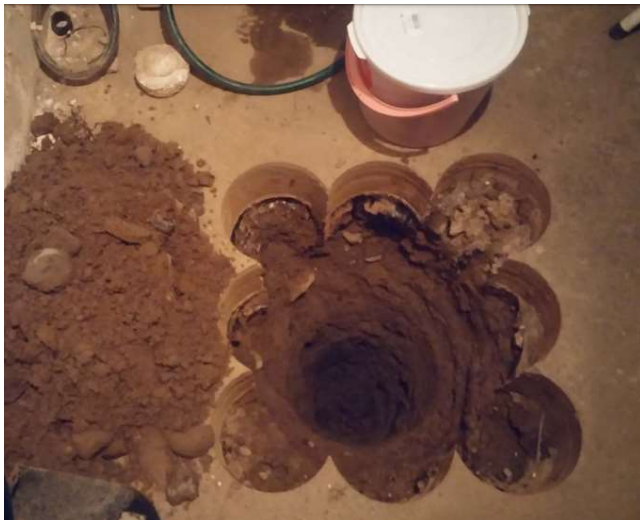
**Figure 4.2.** Excavation site used for CD injections at site Karjaa

At the site 100 litres of 5% CD were poured into the excavation site with a two week interval between injections (Figure 4.2.). This was the maximum volume of water that could be added in a single dose due to the low permeability. Soil was sampled before and after the experiment period for fragment analysis. The water quality was monitored from samples withdrawn from ground water wells during each site visit.

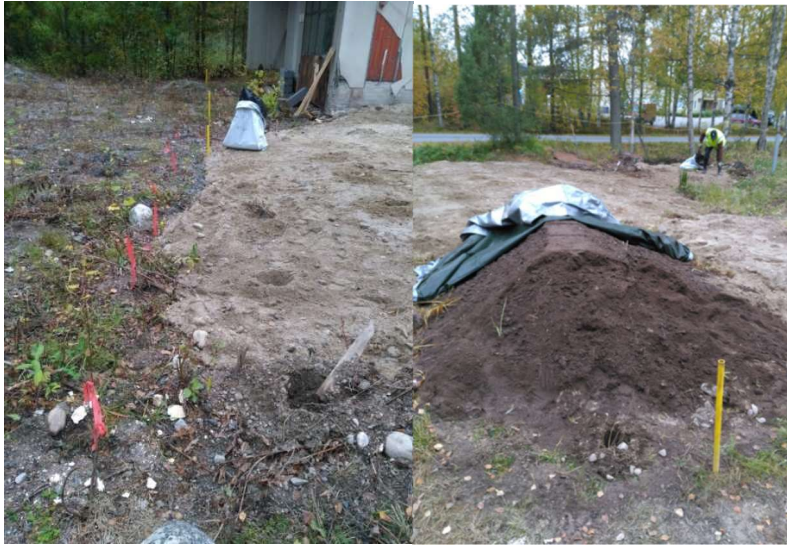
**Figure 5.1.** Oil and Hb-contaminated hot spots removed by digging before starting the planting.

In 2017, two spots on the site were found to have very high concentrations of hydrocarbons and heavy metals, and they had to be removed by excavation before starting of the planting (Figure 5.1.). The soil at the site was very stony and compacted, and drillings had to be done prior to the planting of hybrid aspen plants in 2017 (Figure 5.2.).

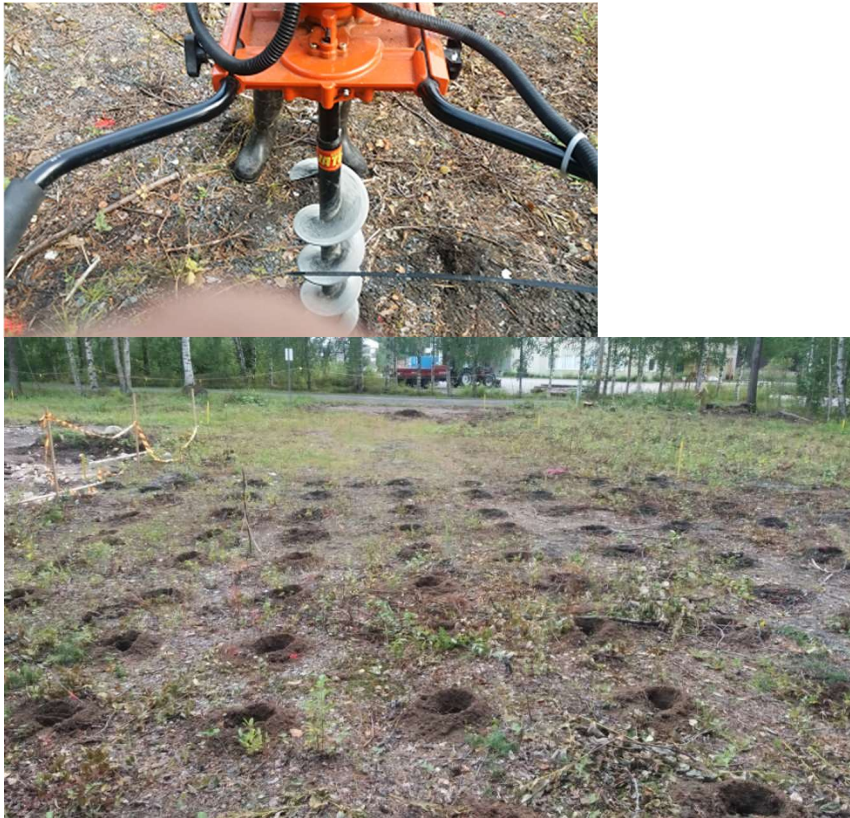
**Figure 5.2 a-b.** Drilling holes for planting.

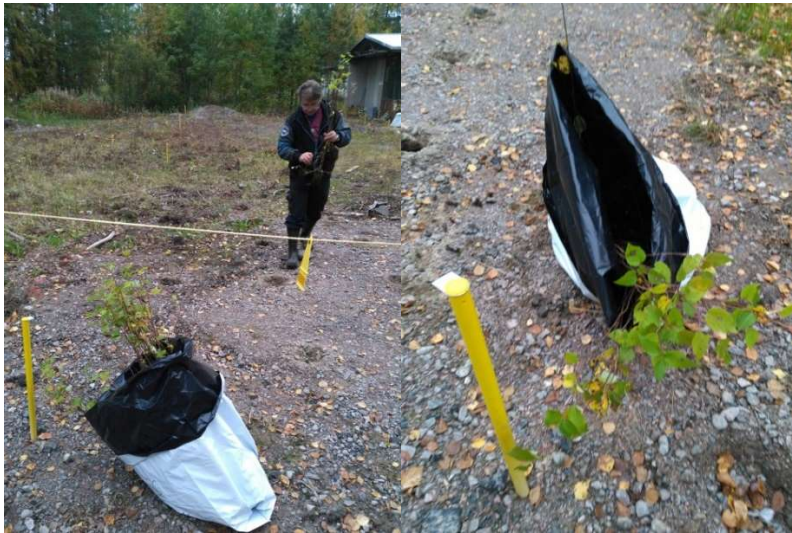
**Figure 5.3 a-b.** Hybrid aspen and European aspen seedlings (*Populus tremula* and *tremuloides*).

Hybrid aspen and European aspen seedlings were chosen for the phytoremediation. Altogether 1200 aspen seedlings in 17 planting blocks were planted during 2017. First sampling of the site was done in the summer of 2017 according to the experimental design to investigate the soil status at the start of the phytoremediation. The DNA from the samples was isolated and PCR amplified for the identification of bacteria and archaea in the contaminated soil. The DNA samples have been sequenced in late 2017 and the bioinformatic analysis was planned to start in 2018 to detect the microbial communities (bacteria and archaea) present in soil. However, as the Populus Group existed the INSURE project in August 2018, the latter analysis has not been performed.

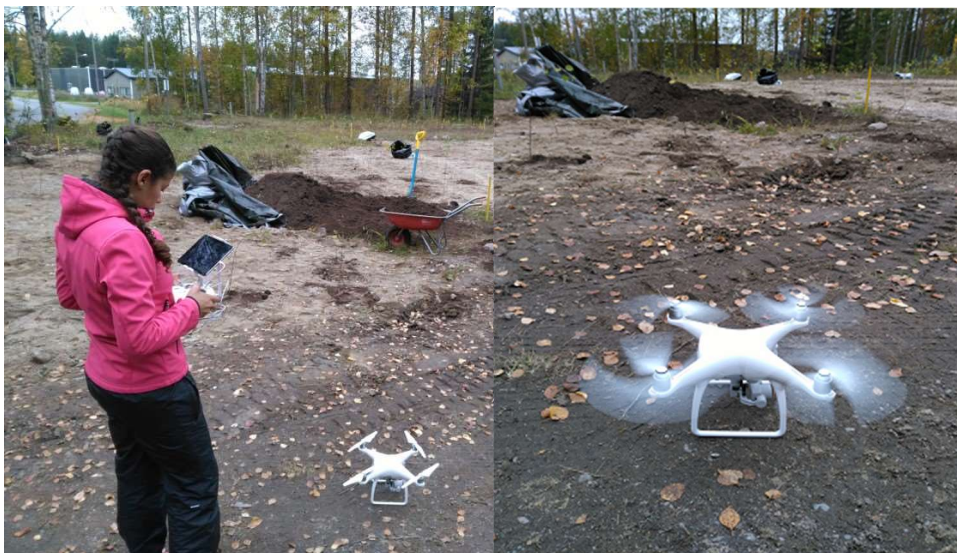
**Figure 5.4 a & b.** DJI Phantom 4 RPAS equipped with iPad for remote control using specially designed computer program for photographing a preselected area with the mini aircraft

The site was photographed using DJI Phantom 4 remotely piloted aircraft system (RPAS) in October 2017. The pictures were used for making GIS maps of the phytoremediation. In the end of June 2018 a monitoring of the phytoremediation (the growth of the seedlings) was conducted using the RPAS system. Due to the dry summer, the hybrid aspens had not grown enough for the actual growth to be detected by the RPAS system.
